REPORT OF INVESTIGATION

ENGINEERING GEOLOGY FOR LAND-USE PLANNING
FOR A PARCEL OF STATE-OWNED LAND EAST
OF WASHINGTON, WASHINGTON COUNTY, UTAH

by
Robert H. Klauk
and
William Mulvey

July 1986

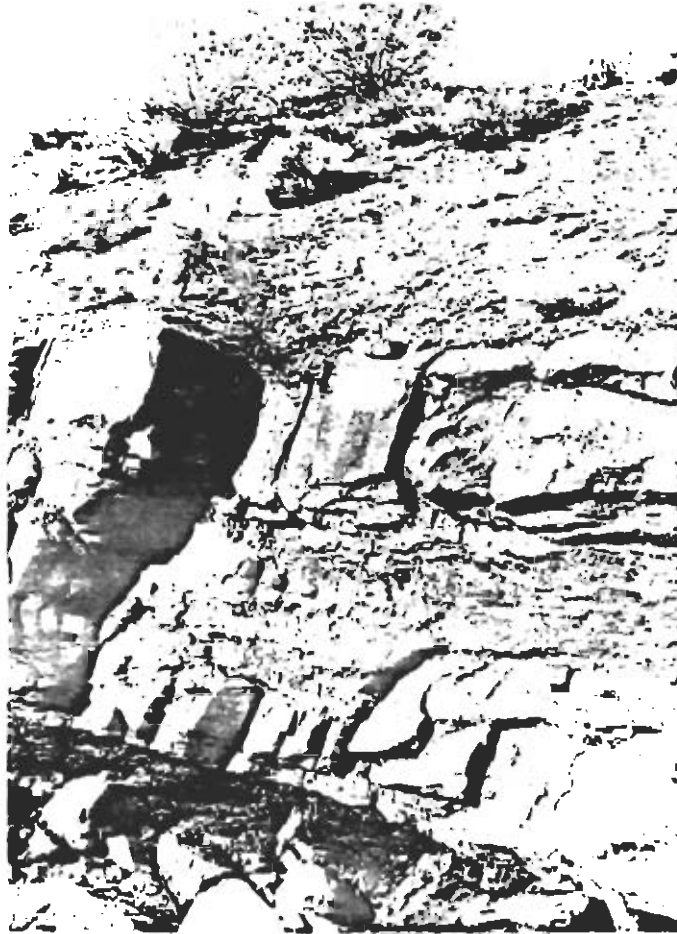
Figure 4. Dinosaur Canyon Sandstone Member of the Moenave Formation. Field book is used for scale.

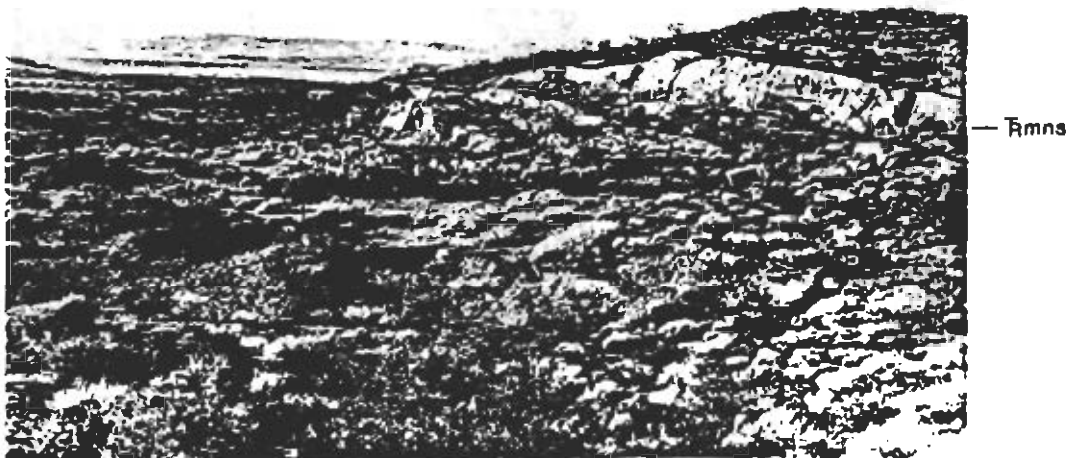
Figure 5. Springdale Sandstone Member of the Moenave Formation—view looking west.

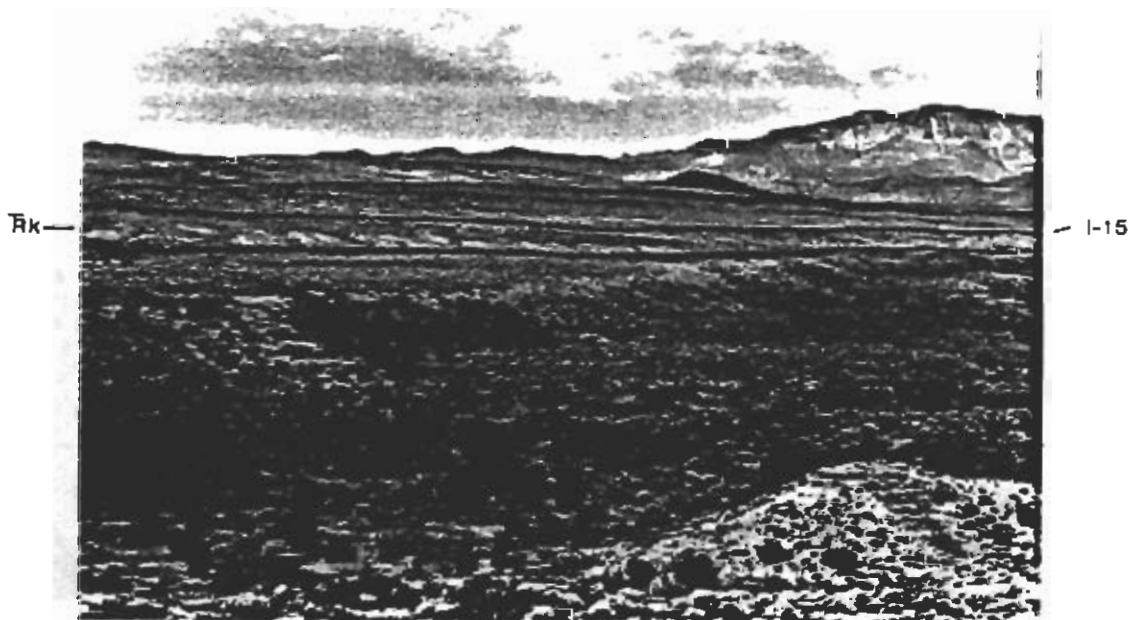
Figure 6. Kayenta Formation—view looking north.

The Petrified Forest Member of the Chinle Formation consists of variegated red-brown, purple, green, and blue shale with local sandstone, gypsum, and bentonite interbeds. Disconformably overlying this unit is the Dinosaur Canyon Sandstone Member of the Moenave Formation which consists of red to green, thin-bedded shale, siltstone, and sandstone (fig. 4). Overlying the Dinosaur Canyon Member is the Springdale Sandstone Member which is a ledge-forming white to red sandstone with thin shale lenses (Harshbarger, and others, 1957; Cook, 1960; figs. 3 and 5). This member of the Moenave Formation is conformably overlain by the Kayenta Formation (figs. 3 and 6). The Kayenta Formation consists of interbedded red sandstone, siltstone, and shale.

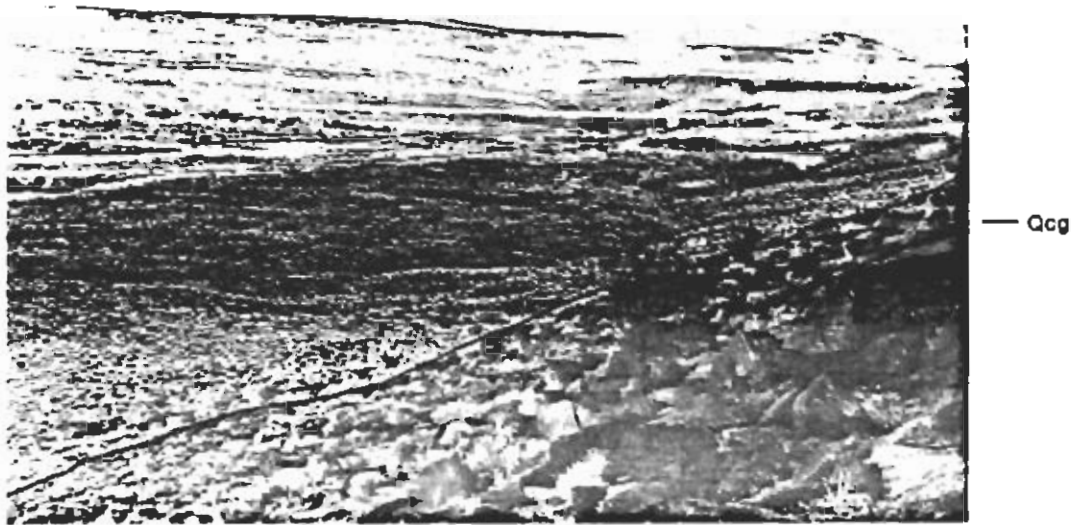
Figure 7. Basalt colluvium covering west flank of Washington for Black Ridge—view looking north.

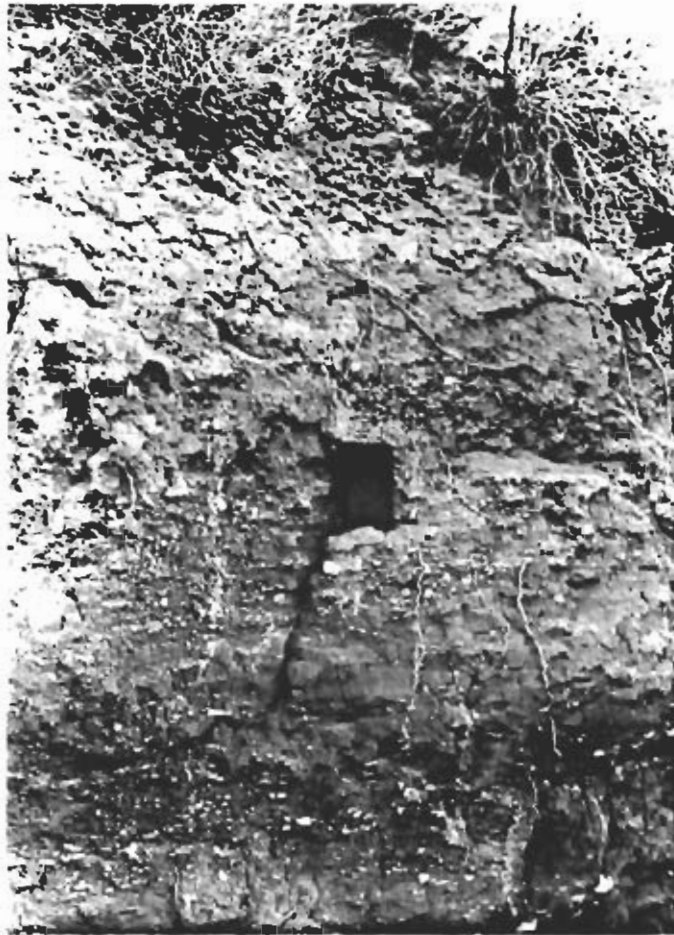
Figure 11. Alluvial clay, silt, sand, and gravel in bank of Grapevine Pass Wash.

Transported soils include: 1) alluvium, 2) eolian deposits, 3) colluvium, and 4) fill. Alluvium (fig. 3) is principally sand (SP), but includes silty and clayey sand (SM, SC, SM-SC), gravel (GP), and silty and clayey gravel (GM, GC, GM-GC) (fig. 11). Flood-deposited boulders, as much as 4 feet in diameter, are found in the channel of Grapevine Pass Wash (fig. 12). Eolian deposits consist of alluvial sand reworked by the wind, forming dunes at some locations (fig. 13). The USCS symbol for these deposits is SP. In many areas it is difficult to differentiate between the eolian and alluvial deposits. Where this occurs a dual symbol is used on figure 3 (Qal/Qes). Colluvial deposits consist of cobbles and boulders forming a layer of variable thickness on slopes up to 30 percent (figs. 7 and 8). Immediately adjacent to the site on the north is an area reworked to construct the small dam (figs. 2 and 14). Part of the embankment is on site and is shown on figure 3 as F1. The dam appears to have been constructed from alluvial/eolian deposits similar to those described on the site.

Debris, similar to that shown in figure 11, is evidence of significant flooding in these tributaries. The flood hazard in Grapevine Pass Wash has been reduced by the construction of the previously described dam (fig. 14). However, the dam does not appear to be constructed to standards that will contain a 100-year flood. No water was in the dam at the time of the site investigation. In addition to possible channel flooding the site could experience sheet wash in areas where bedrock is at or very near the surface. The areas considered most susceptible are delineated in figure 15.

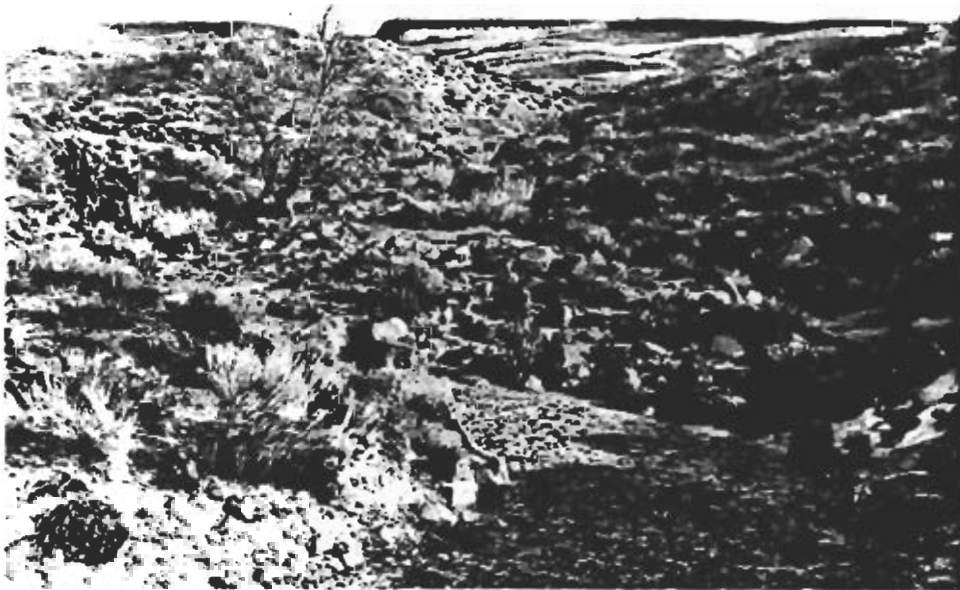
Figure 12. Debris flood deposits in channel of Grapevine Pass Wash.

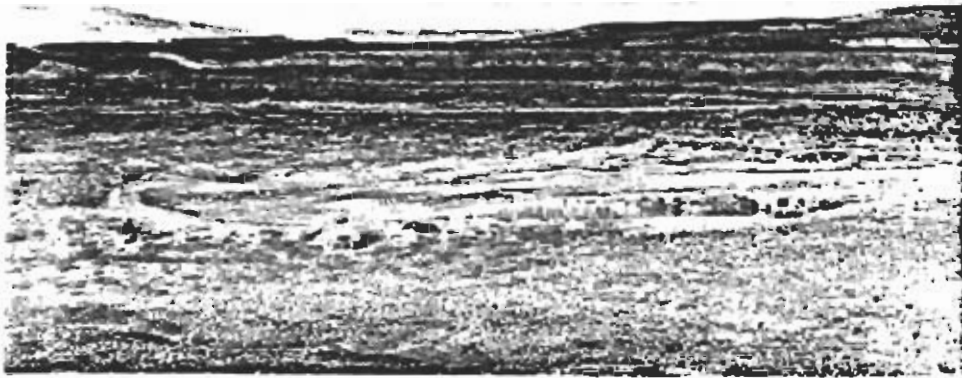
Figure 14. Dam and graded area.
